Smart Performance Program

Trouble Shooting Measurements in 4-High Cold Rolling Mill

Industry: Steel and non-ferrous metals

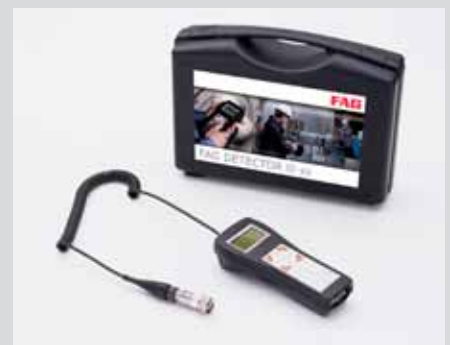
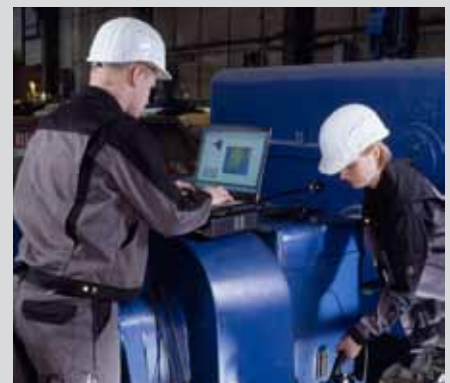
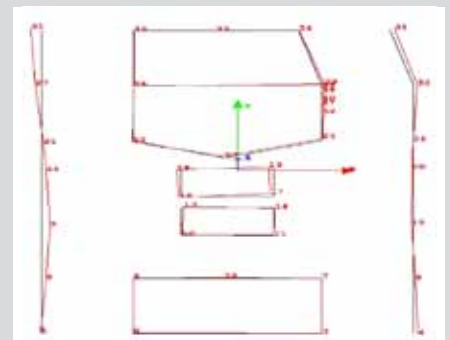
In no time at all, the Schaeffler Group service division organized the necessary trouble shooting activities. Two experienced experts carried out various vibration measurements and a modal analysis. The results showed an irregularity in the region of the work rolls and a heavy frame deflection in the direction of rolling. The upper chock – and consequently the upper work roll – rotated freely in the frame, causing a cyclic reduction of the roll gap. As a result, chatter marks were produced on the steel strip at regular intervals.

- Modal analysis
- Operating vibration measurement
- Bump test
- Run up / coast down measurements

Thanks to the trouble shooting carried out by the service experts, the cause of the chatter marks on the rolled strip was determined in no time at all. Immediately afterwards, the steel producer initiated the necessary design modifications in collaboration with the plant builder. In this way the problems with the rolling stand were solved quickly, and further costly production losses have been avoided.
